# Preliminary field experiences on the effects of LSFO and VLSFO on cylinder condition

**Author:** Rathesan Ravendran, Ph. D., MSc. in Mechanical Engineering  
Technology and Innovation Specialist  
Hans Jensen Lubricators A/S

### **Case study 1: Consequences of over-lubrication and BN level mismatch**

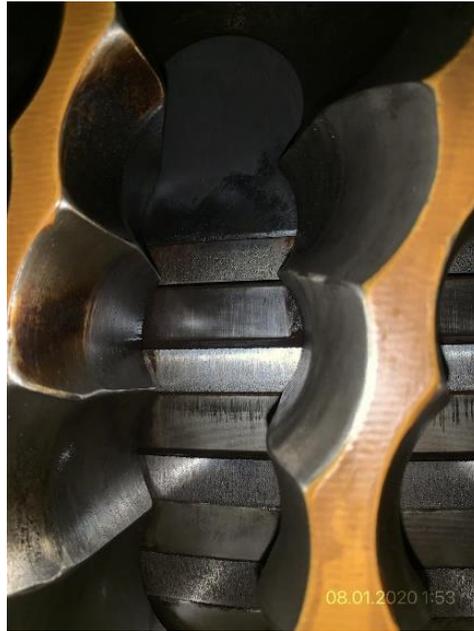
Scavenge-port inspections before and after the changeover (Figure 2 and 3), showed an increased deposit build-up and scuffing of piston rings (Figure 6). Only pictures of unit #6 is presented in this article, but the situation is the same for all cylinder units. Since high wear was observed in the on-board scrape-down analysis, the engine operators sought to deal with the issue by increasing the cylinder lubrication oil feed rate to approximately 1.5 g/kWh. This has however been without any success, as the following port inspection 7 days later showed (Figure 4) an even worse cylinder condition with an increased build-up of calcium deposits.

*Figure 2: Visible scuffing marks on the piston rings*

Scrape-down results after the changeover confirmed high iron content as well as high residual BN, which indicates over-lubrication and mismatch in BN level. The vessel was recommended to change cylinder oil type from 70BN to 40BN, and furthermore reduce the cylinder oil feed rate in order to prevent the issues from calcium deposit build-up. The instructions were followed, and the following inspection (Figure 5) and scrape-down results showed improved cylinder condition (both iron content and BN decreased dramatically by 57.8 % and 24.6 %, respectively). Figure 7 and 8 shows the iron content and residual BN in the scrape-down analysis for the presented period. Since piston rings and cylinder liner are severely scuffed, and since the stuck piston rings cannot be loosened by lubrication oil. Why a complete overhaul of the units is required to reestablish normal cylinder condition.

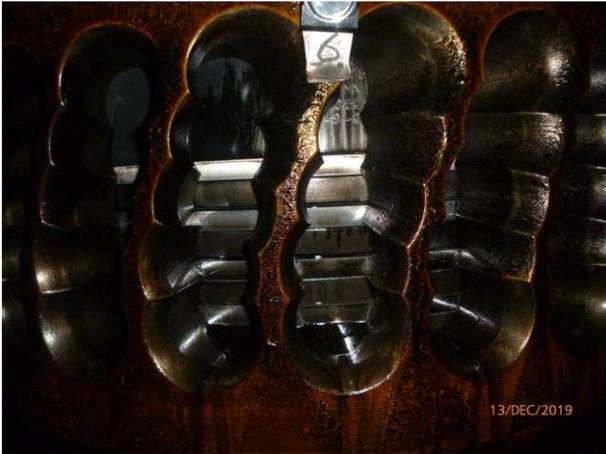
**Figure 3:** Operation on HFO (13/02-2019) – normal condition. Piston rings are well lubricated, and no major deposit build-up on the piston top land area.

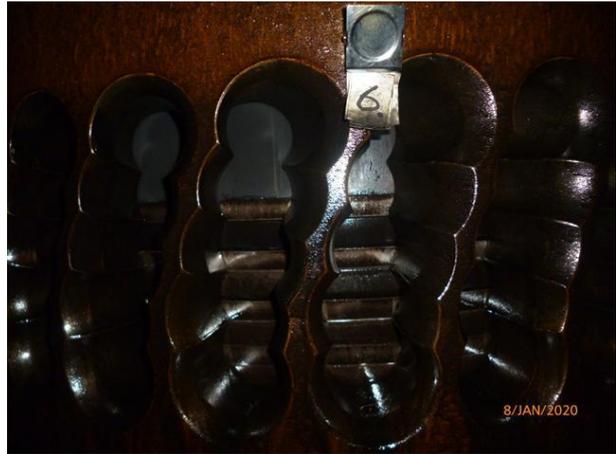
**Figure 4:** Operation on LSFO (08/01-2020) - bad condition. The pistons and ring packs across all cylinders seem to be over-lubricated. There are deposits on the piston top land, and visible scuffing marks on the piston rings (Figure 6)

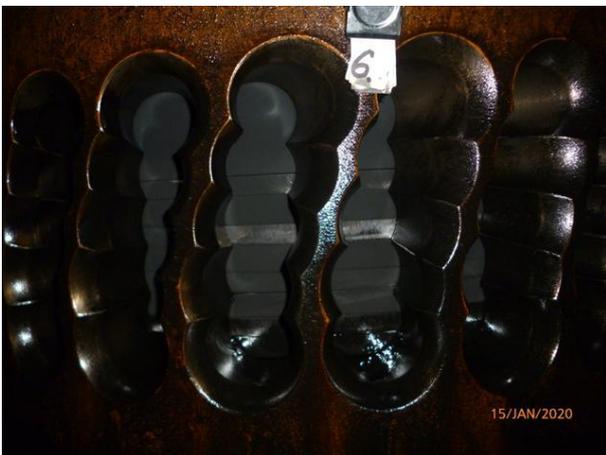
**Figure 5:** Operation on LSFO (15/01-2020) - very bad condition. Piston rings are stuck in their grooves. This is indicated as the upper piston ring is partly black from combustion residues, and the ring land below the piston ring is partly dry and without cylinder lubrication oil due to blow-by.

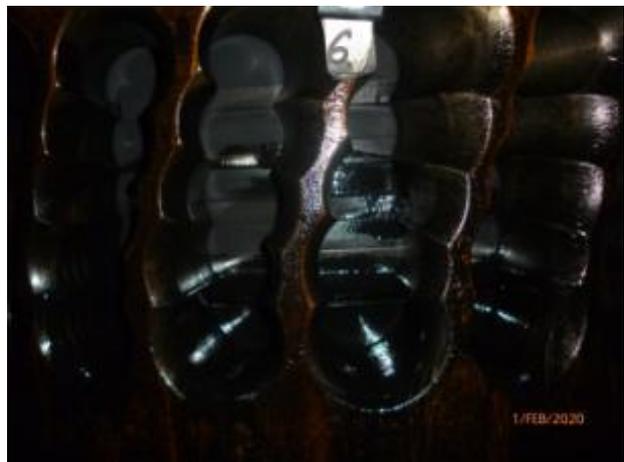
**Figure 6:** Operation on LSFO (01/02-2020) - bad condition. The upper piston ring is partly stuck in its groove. This is indicated as the upper piston ring is partly black from combustion residues, and the ring land below the piston ring is partly dry and without cylinder lubrication oil due to blow-by.

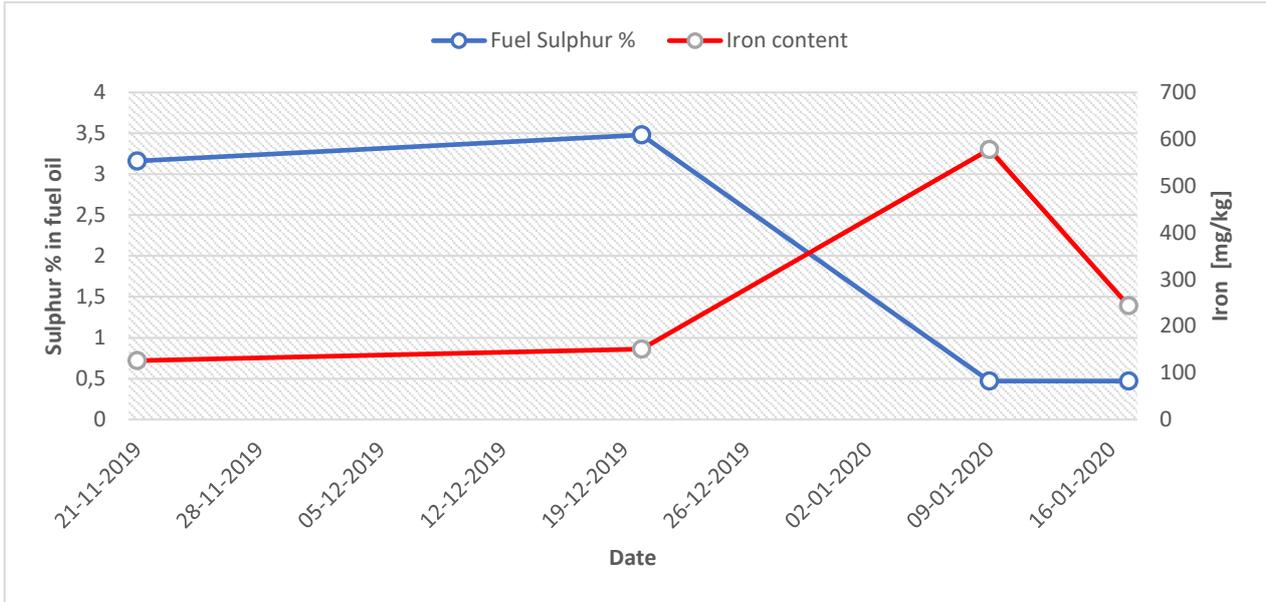
**Figure 7:** Iron content in scrape-down analysis versus fuel sulphur content

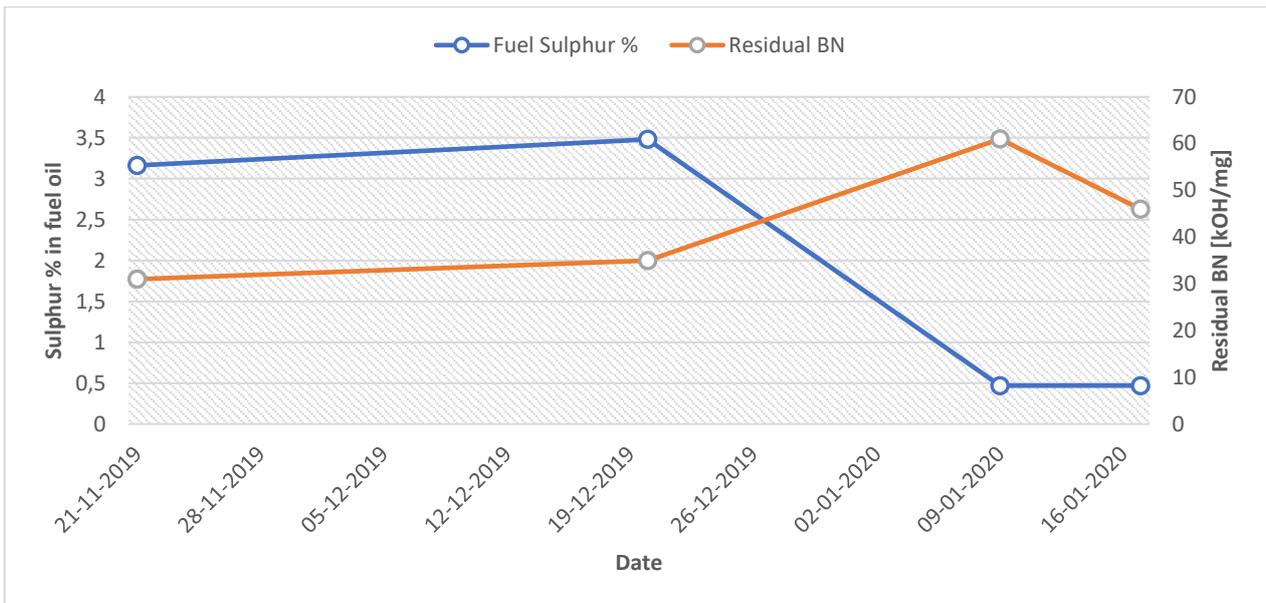
**Figure 8:** Residual BN content in scrape-down analysis versus fuel sulphur content
